ARKANSAS
Department of Environmental Quality

MEMORANDUM

SUBJECT: Diaz Intermediates Corporation
ARR000005843
AFIN 18-00401

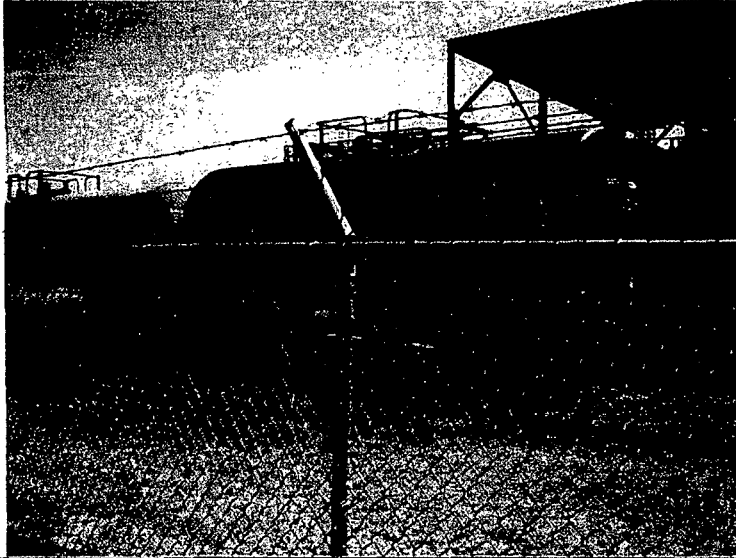
Location:	Diaz Intermediates Corp., 301 Wyanoke Rd., West Memphis, AR 72301						
Photographer:	Les Branscum, ADEQ				Witness:	Penny Wilson, ADEQ	
Photo #	1	Of	10		Date:	22 AUG 07	Time: 1105
Description:	View of Diaz rail spur from outside facility fence, west side. Rail car is placarded Flammable Liquid, UN 1993.

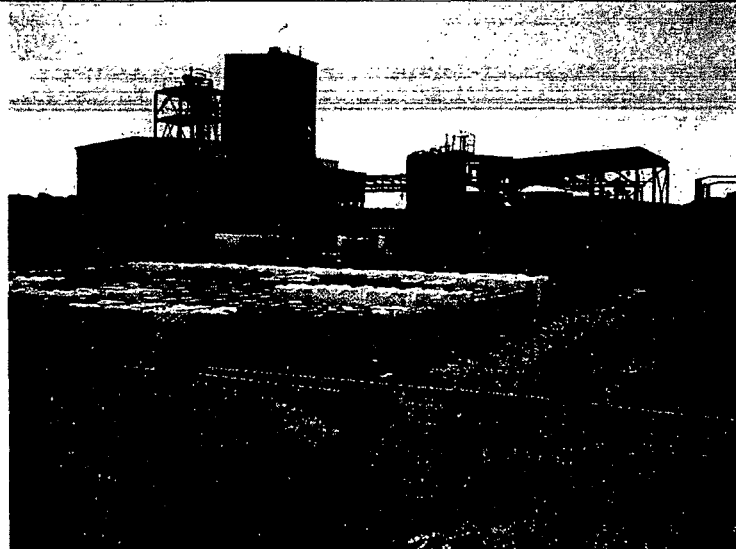
Photographer:	Les Branscum, ADEQ				Witness:	Penny Wilson, ADEQ	
Photo #	2	Of	10		Date:	22 AUG 07	Time: 1107
Description:	View of Diaz facility from NW corner on rail spur. Rail car is placarded Flammable Liquid, UN2387 and labeled Fluorobenzene.

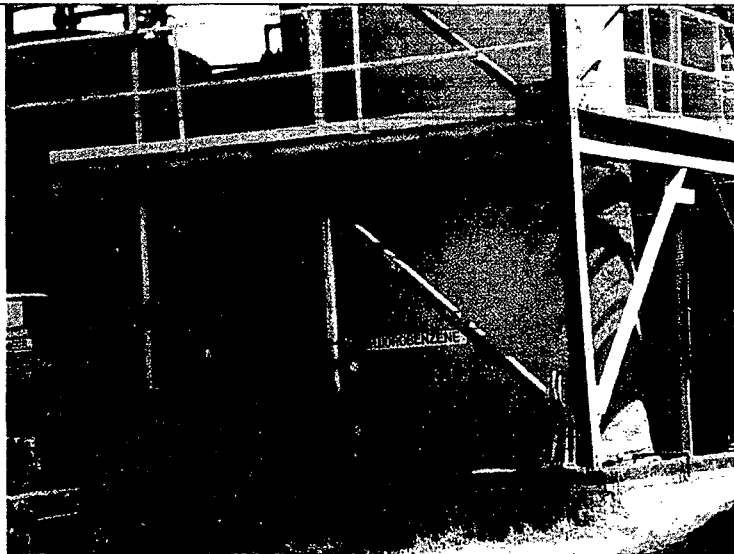
Photographer:	Les Branscum, ADEQ			Witness:	Penny Wilson, ADEQ		
Photo #	4	Of	10	Date:	22 AUG 07	Time:	1123
Description:	Fluorobenzene tank as viewed through the fence on the west side of the facility, (tank in above photo is to the left). Both photos are facing east.

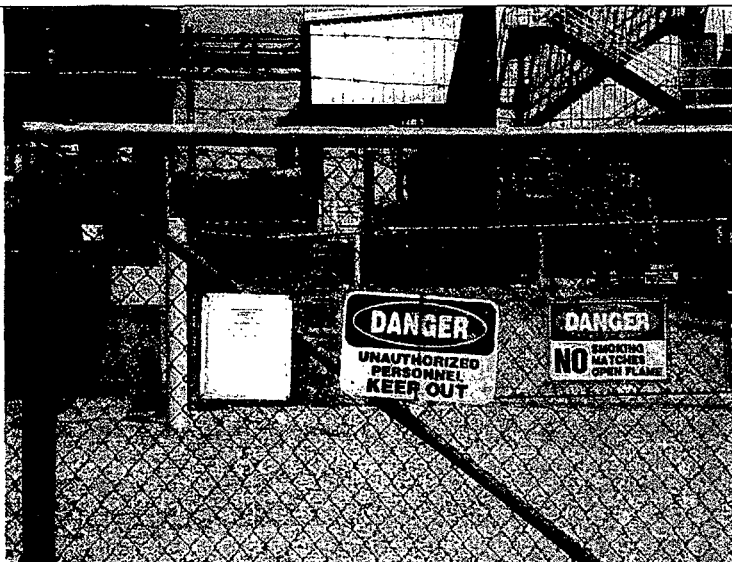
Location:	Diaz Intermediates Corp., 301 Wyanoke Rd., West Memphis, AR 72301						
Photographer:	Les Branscum, ADEQ				Witness:	Penny Wilson, ADEQ	
Photo #	7	Of	10		Date:	22 AUG 07	Time: 1145
Description:	Photo of front gate showing warning signs and secondary entrance in background, facing north.

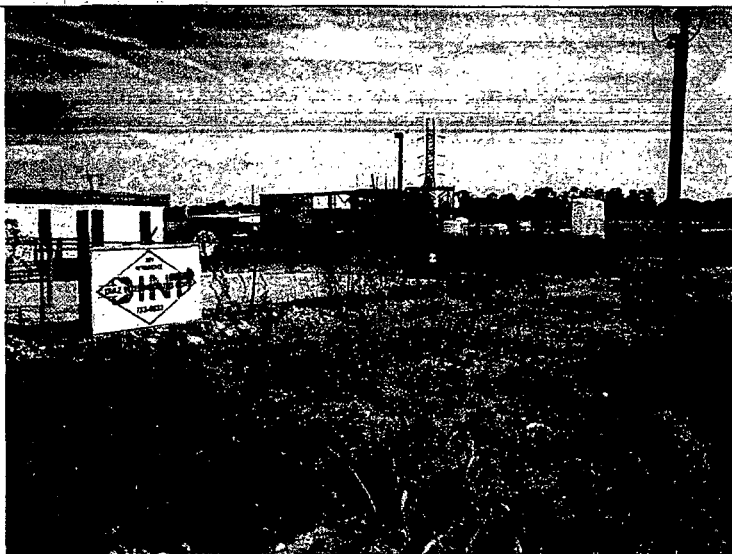
Photographer:	Les Branscum, ADEQ				Witness:	Penny Wilson, ADEQ	
Photo #	8	Of	10		Date:	22 AUG 07	Time: 1146
Description:	Diaz facility sign with the Tetra facility in the background to the east.

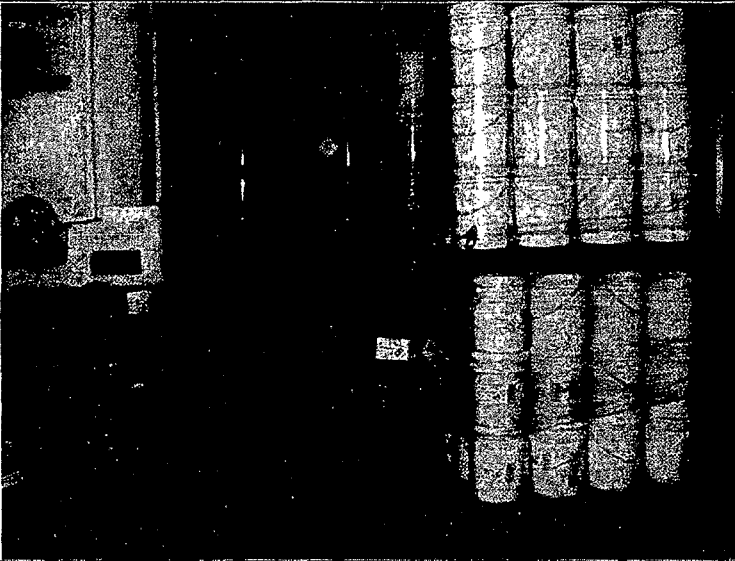
Location:	Diaz Intermediates Corp., 301 Wyanoke Rd., West Memphis, AR 72301						
Photographer:	Les Branscum, ADEQ				Witness:	Penny Wilson, ADEQ	
Photo #	1	Of	67		Date:	28 AUG 07	Time: 1038
Description:	SW corner of the Diaz warehouse. On the right are 5 gal pails of P-Dibromobenzene (99%) and the 55 gal blue drums contain 2-Bromopyridine. Photo facing south.

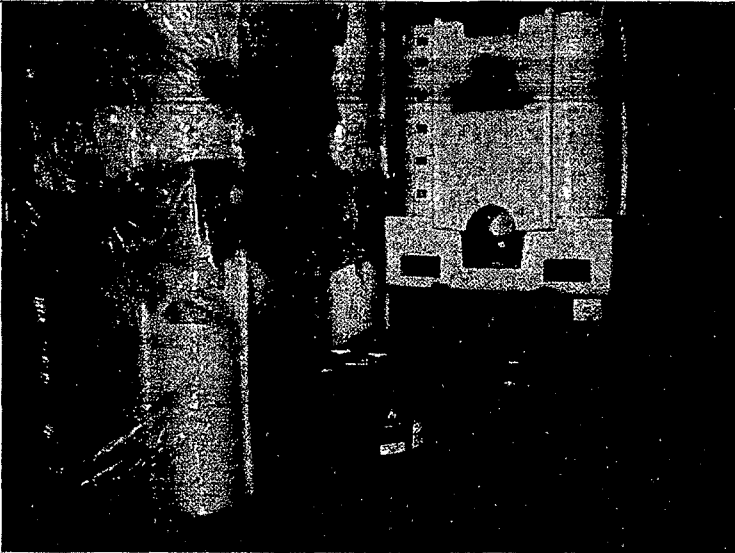
Photographer:	Les Branscum, ADEQ				Witness:	Penny Wilson, (ADEQ)	
Photo #	2	Of	67		Date:	28 AUG 07	Time: 1043
Description:	Items to the left of those in photo #1 include black 55 gal drums and 275 gal totes of n-Propanol (fresh). The 300 gallon plastic wrapped totes on the left are empty.

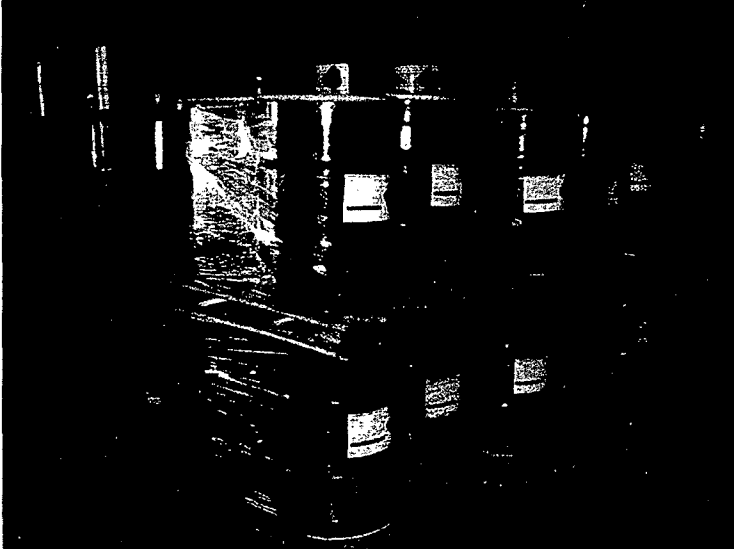
Photographer:		Les Branscum, ADEQ			Witness:		Penny Wilson, ADEQ	
Photo #	4	Of	67		Date:	28 AUG 07	Time:	1050
Description:		Drums to the left of those in photo 3; black 30 gal drums of Aluminum Chloride, Anhydrous and blue 55 gal drums of Methanol.

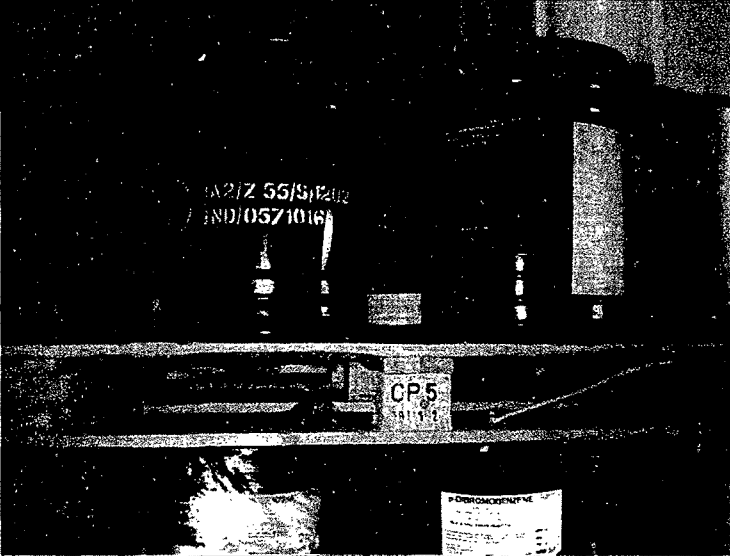
Location:	Diaz Intermediates Corp., 301 Wyanoke Rd., West Memphis, AR 72301						
Photographer:	Les Branscum, ADEQ				Witness:	Penny Wilson, ADEQ	
Photo #	9	Of	67		Date:	28 AUG 07	Time: 1111
Description:	Two 5 gal cans on top of the stack in photo 8. These are labeled 'Phosphorus, Amorphous- Red Phosphorous (99%)'.

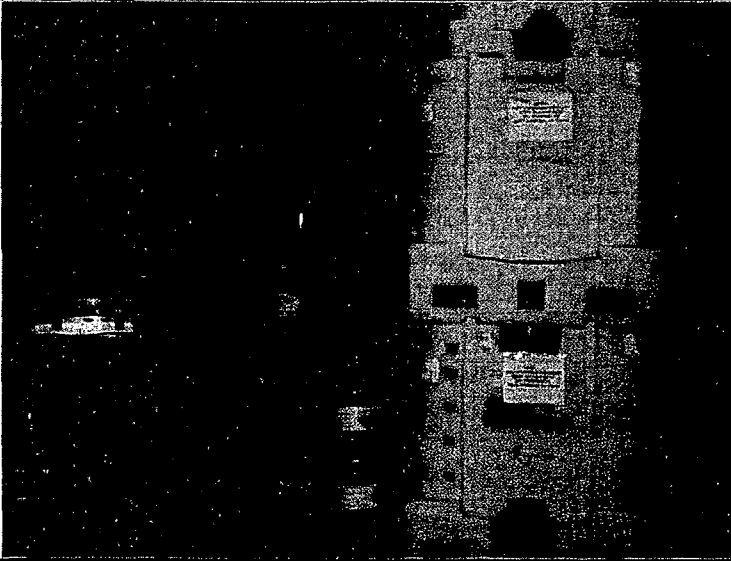
Location:	Diaz Intermediates Corp., 301 Wyanoke Rd., West Memphis, AR 72301						
Photographer:	Les Branscum, ADEQ				Witness:	Penny Wilson, ADEQ	
Photo #	11	Of	67		Date:	28 AUG 07	Time: 1118
Description:	Northwest corner of Diaz warehouse showing 220 gal totes of N-Propylbromide and black 65 lb cans of Ferric Chloride.

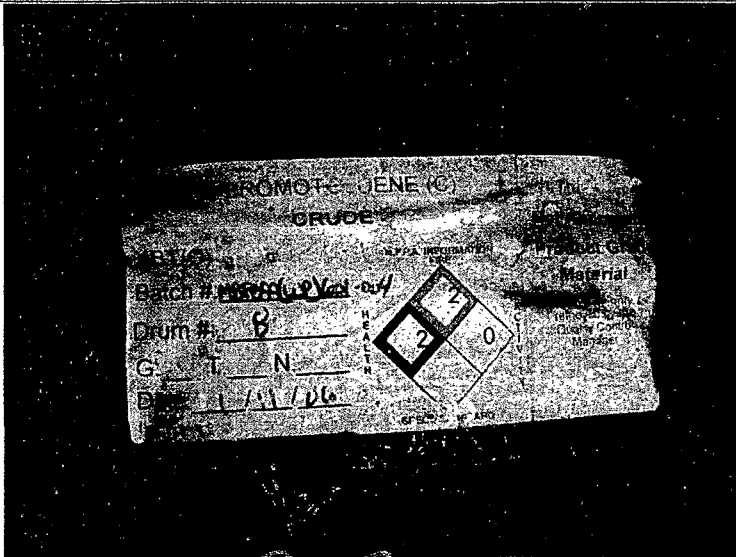
Location:		Diaz Intermediates Corp., 301 Wyanoke Rd., West Memphis, AR 72301						
Photographer:		Les Branscum, ADEQ			Witness:		Penny Wilson, ADEQ	
Photo #	15,16	Of	67		Date:	28 AUG 07	Time:	1135
Description:		Close up of label on drum of Bromotoluene (C) showing date of 1-11-06. This drum was on the right side of the loading dock adjacent to the warehouse. Photos 15&16 were of the same label.

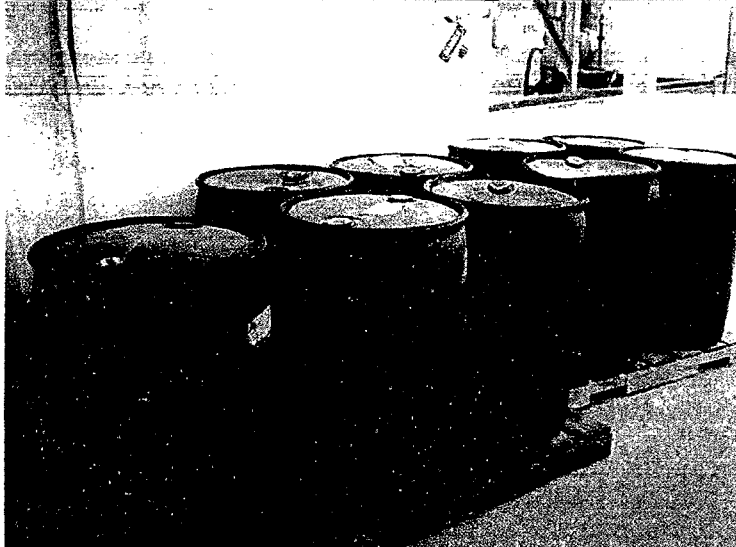
Photographer:		Les Branscum, ADEQ			Witness:		Penny Wilson, ADEQ	
Photo #	17	Of	67		Date:	28 AUG 07	Time:	1138
Description:		North end of the loading dock showing the condition of some of the poly drums. These drums were filled while the contents were hot, causing them to indent.

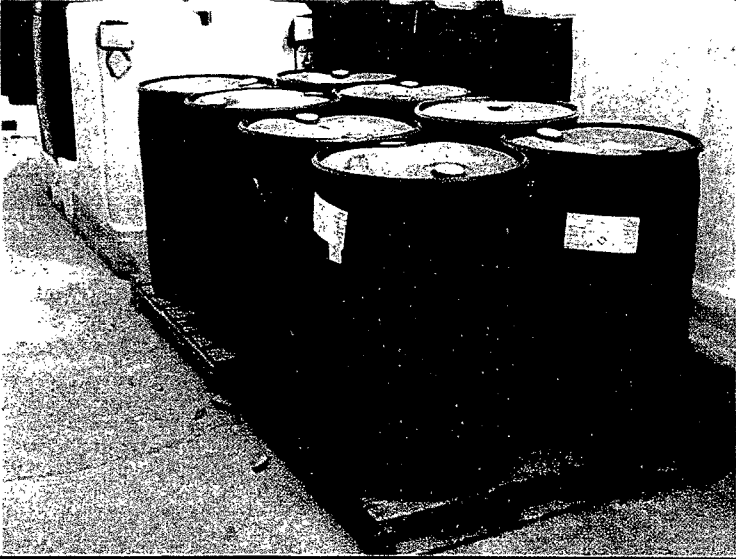
Location:		Diaz Intermediates Corp., 301 Wyanoke Rd., West Memphis, AR 72301						
Photographer:		Les Branscum, ADEQ			Witness:		Penny Wilson, ADEQ	
Photo #	18	Of	67		Date:	28 AUG 07	Time:	1150
Description:		Facing north on the forklift pad. Eight 55 gal drums labeled 'MBFB65 (WP) (WET PURE)'.

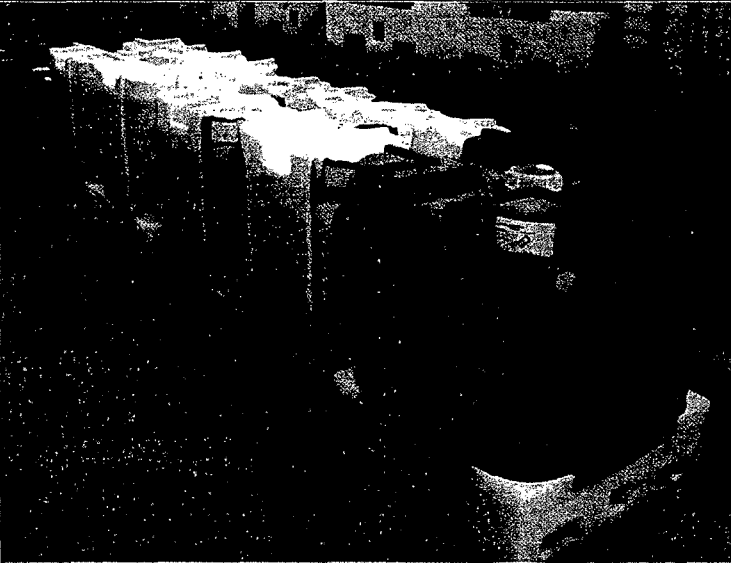
Location:	Diaz Intermediates Corp., 301 Wyanoke Rd., West Memphis, AR 72301						
Photographer:	Les Branscum, ADEQ				Witness:	Penny Wilson, ADEQ	
Photo #	20	Of	67		Date:	28 AUG 07	Time: 1155
Description:	275 gal totes on right side of forklift path, facing NE. The blue tote is labeled M-Bromofluorobenzene; white ones contain pit water (zinc).

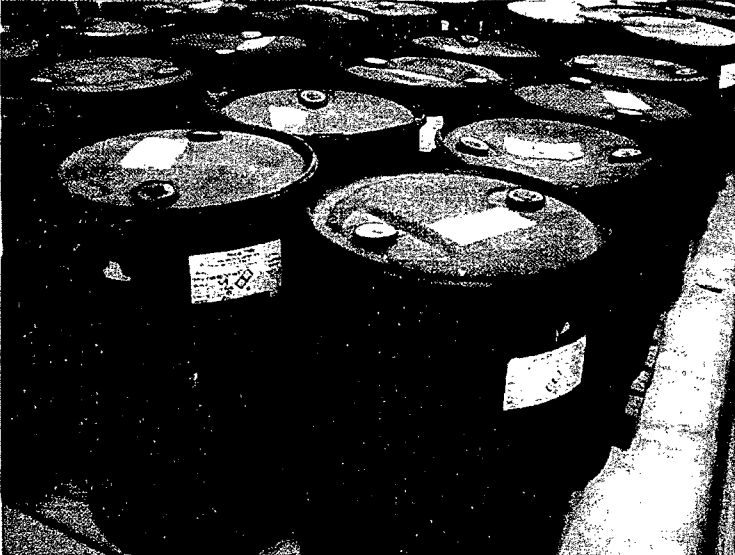
Location:		Diaz Intermediates Corp., 301 Wyanoke Rd., West Memphis, AR 72301						
Photographer:		Les Branscum, ADEQ			Witness:		Penny Wilson, ADEQ	
Photo #	22	Of	67		Date:	28 AUG 07	Time:	1159
Description:		Left side of forklift path facing north. The eight 55 gal drums centered in the photo are all labeled 'DBFB, Dibromotoluene Mix'.

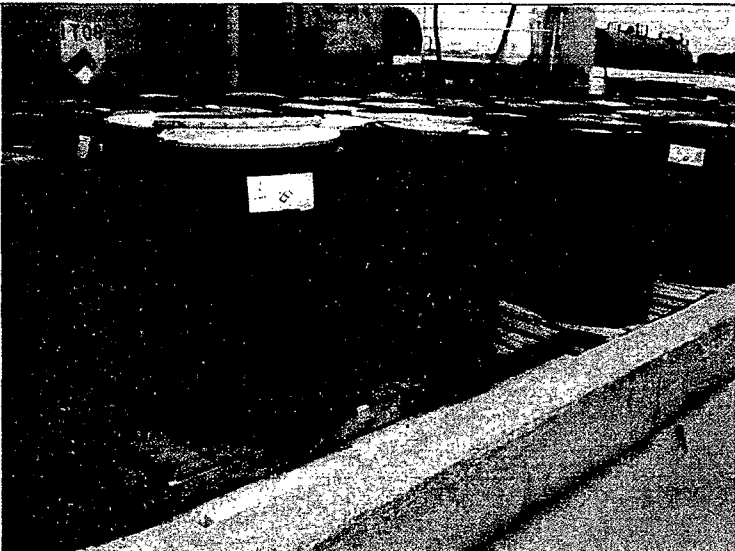
Photographer:		Les Branscum, ADEQ			Witness:		Penny Wilson, ADEQ	
Photo #	23	Of	67		Date:	28 AUG 07	Time:	1202
Description:		Drums just north of those in photo 22. Blue drum to the left is labeled 'MBFB Waste pads/filters'. New and old tank farms are to the left of the photo.

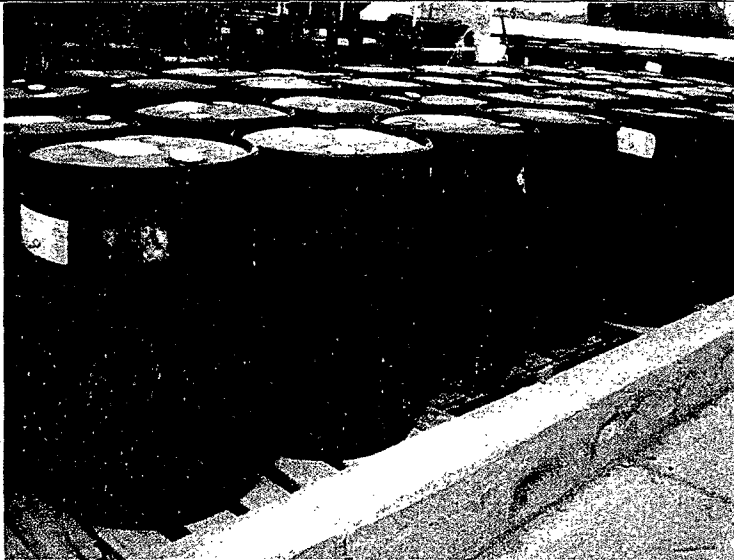
Location:	Diaz Intermediates Corp., 301 Wyanoke Rd., West Memphis, AR 72301							
Photographer:	Les Branscum, ADEQ				Witness:	Penny Wilson, ADEQ		
Photo #	24	Of	67		Date:	28 AUG 07	Time:	1204
Description:	Drums on pad east of 'tank farm', facing NW. Drum on left is labeled 'Mixed Organics (R) Overhead'.

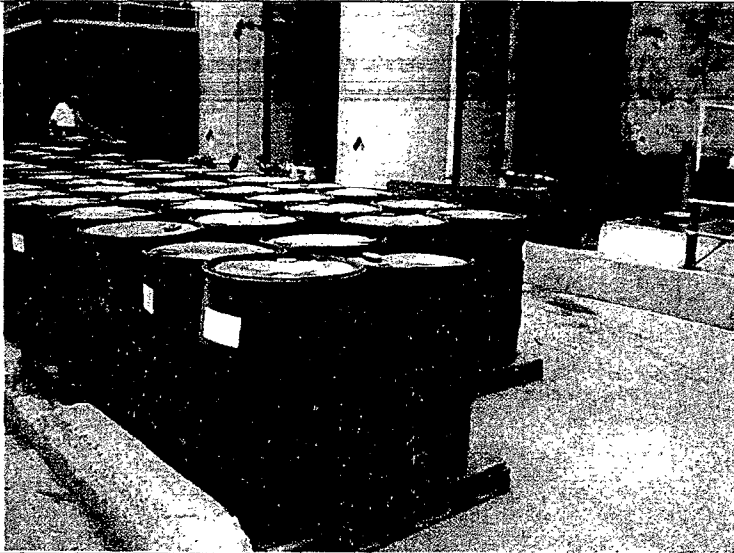
Photographer:	Les Branscum, ADEQ				Witness:	Penny Wilson, ADEQ		
Photo #	25	Of	67		Date:	28 AUG 07	Time:	1212
Description:	Opposite view of drums in photo 24, facing SW with tank farm in background. Last 4 drums on the end of the left row and 2 rows to the right are labeled X-Bromotoluene (T) Bottoms.

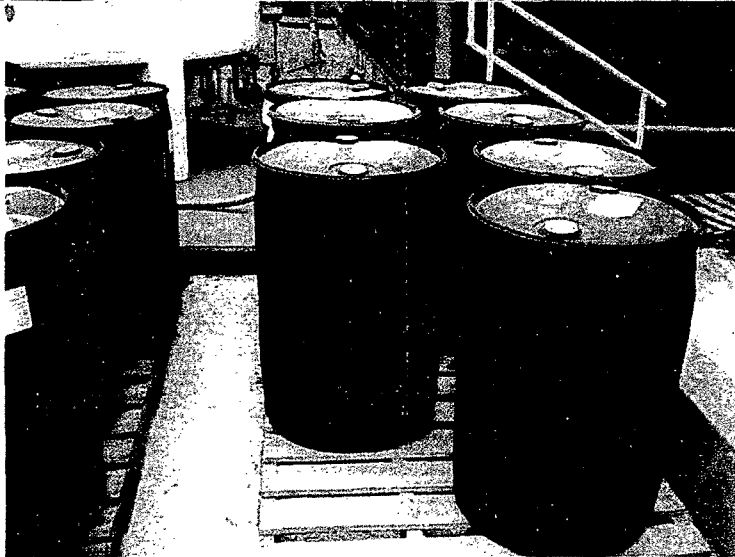
Location:	Diaz Intermediates Corp., 301 Wyanoke Rd., West Memphis, AR 72301						
Photographer:	Les Branscum, ADEQ				Witness:	Penny Wilson, ADEQ	
Photo #	26	Of	67		Date:	28 AUG 07	Time: 1215
Description:	Drums of X-Bromotoluene (C) Crude on opposite end of drums in photo 25, facing south.

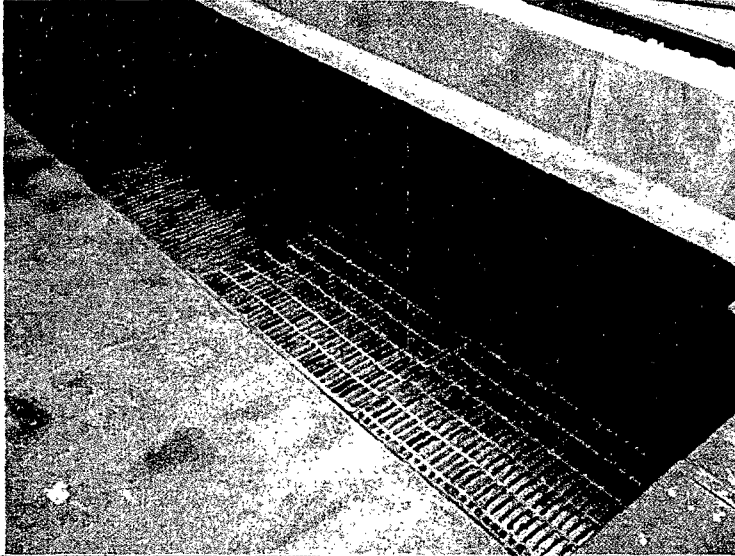
There is a sump that runs along the North wall of the secondary containment for this tank farm. The sump is covered with a metal grating that is extremely deteriorated. At the time of the site visit there was liquid in the sump that had a pH of 6.

Location:		Diaz Intermediates Corp., 301 Wyanoke Rd., West Memphis, AR 72301						
Photographer:		Les Branscum, ADEQ			Witness:		Penny Wilson, ADEQ	
Photo #	28	Of	67		Date:	28 AUG 07	Time:	1328
Description:		North side of containment sump in old tank farm. Spilfyter test strip indicated a Ph of 6 in the sump water.

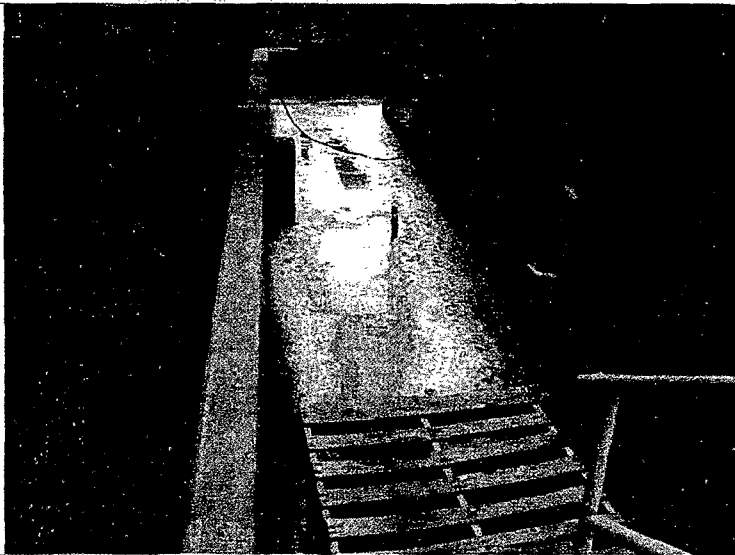
There is an accumulation of some type of liquid with a crystal-like substance on top on the southern end of the secondary containment for this tank farm. The pH of the liquid was between 9 and 10.

Photographer:		Les Branscum, ADEQ			Witness:		Penny Wilson, ADEQ	
Photo #	29	Of	67		Date:	28 AUG 07	Time:	1331
Description:		New tank farm containment area with standing water. The Spilfyter test strip indicated the Ph for this water between 9 and 10.

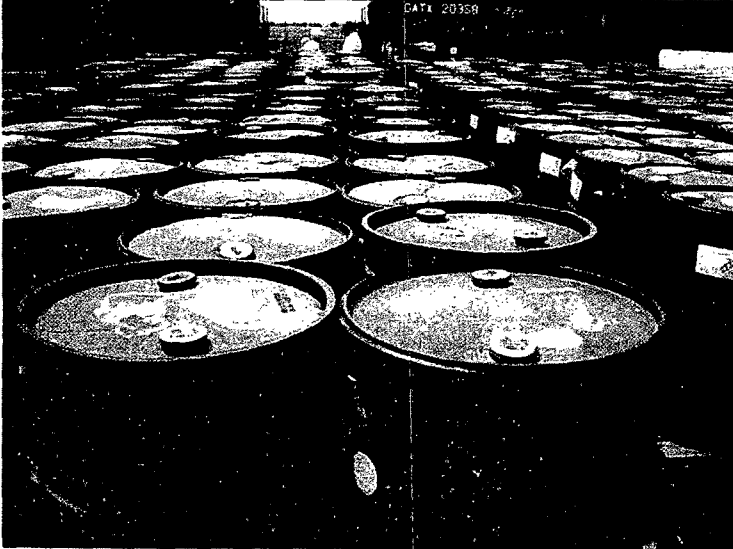
Photographer:		Les Branscum, ADEQ			Witness:		Penny Wilson, ADEQ	
Photo #	33	Of	67		Date:	28 AUG 07	Time:	1352
Description:		Rows 5&6 on the drum pad, facing west.

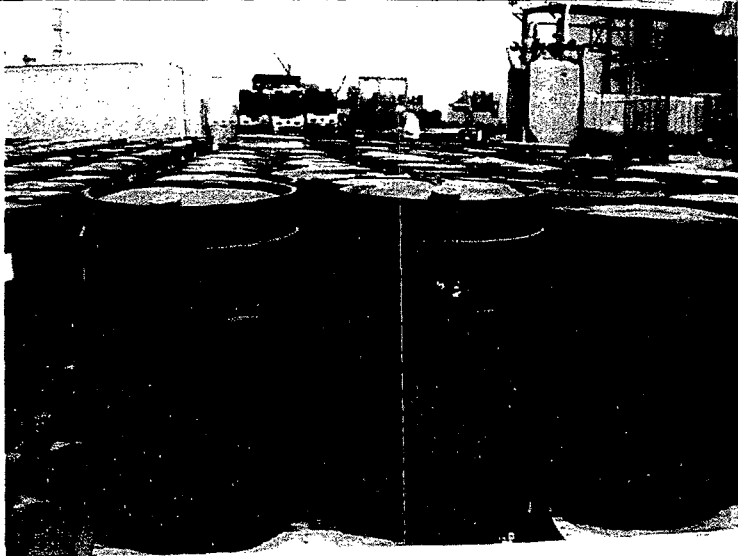
Location:	Diaz Intermediates Corp., 301 Wyanoke Rd., West Memphis, AR 72301						
Photographer:	Les Branscum, ADEQ				Witness:	Penny Wilson, ADEQ	
Photo #	34	Of	67		Date:	28 AUG 07	Time: 1354
Description:	View of rows 5&6 from opposite end showing blue drum on right has a bulging top. Drum is labeled 'M-Dibromobenzene'. Photo facing east.

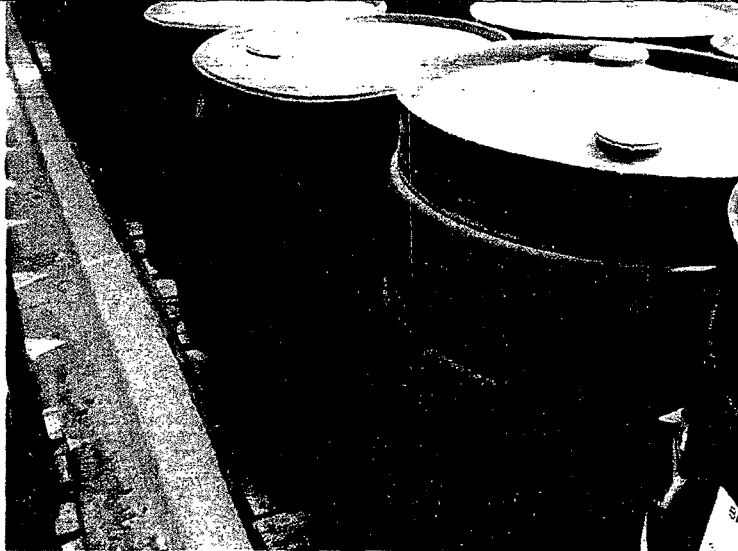
Photographer:	Les Branscum, ADEQ				Witness:	Penny Wilson, ADEQ	
Photo #	35	Of	67		Date:	28 AUG 07	Time: 1358
Description:	Poly drum (3 rd from end in above photo of row 6) not leaking but crushed in, no label visible. Photo facing east.

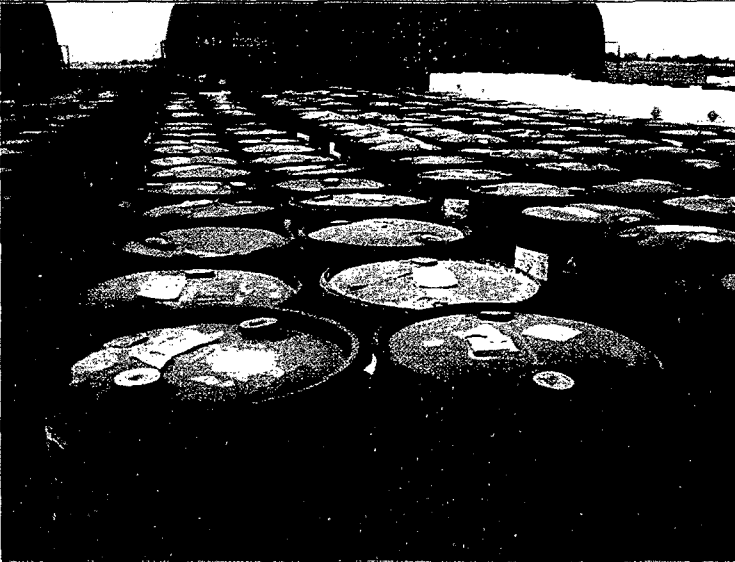
Location:		Diaz Intermediates Corp., 301 Wyanoke Rd., West Memphis, AR 72301						
Photographer:		Les Branscum, ADEQ			Witness:		Penny Wilson, ADEQ	
Photo #	36	Of	67		Date:	28 AUG 07	Time:	1402
Description:		Rows 7&8 on drum pad, facing west. Rail car in background is labeled 'Fluorobenzene' UN 2387, Flammable Liquid.

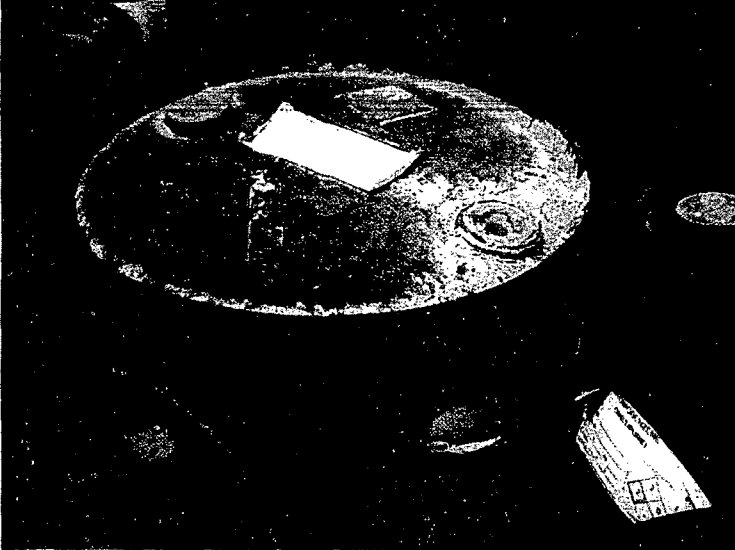
Photographer:		Les Branscum, ADEQ			Witness:		Penny Wilson, ADEQ	
Photo #	37	Of	67		Date:	28 AUG 07	Time:	1403
Description:		Residue on top of 2 nd drum in row 8, photo 36. Drum is labeled 'Bromobenzene recycle'.

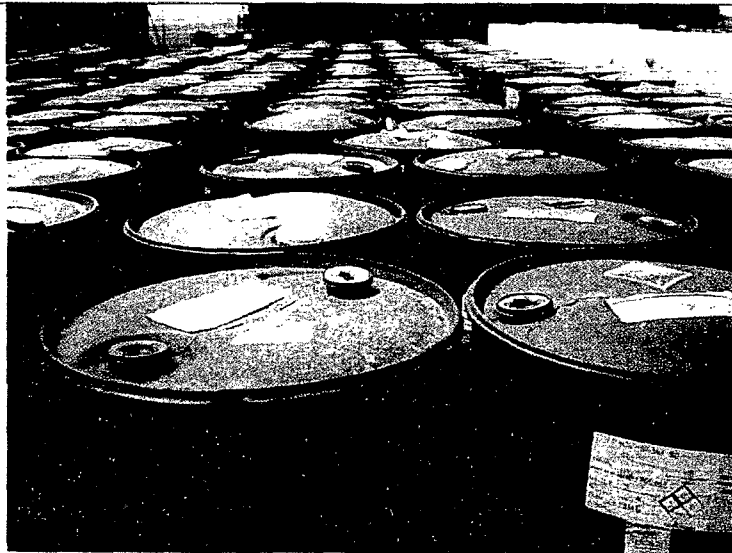
Photographer:		Les Branscum, ADEQ			Witness:		Penny Wilson, ADEQ	
Photo #	39	Of	67		Date:	28 AUG 07	Time:	1406
Description:		Rows 11&12 on drum pad, facing west. First drum in row 12 is labeled 'HCL/HBR mix SG>1.1'. It is also dated 1-31-06.

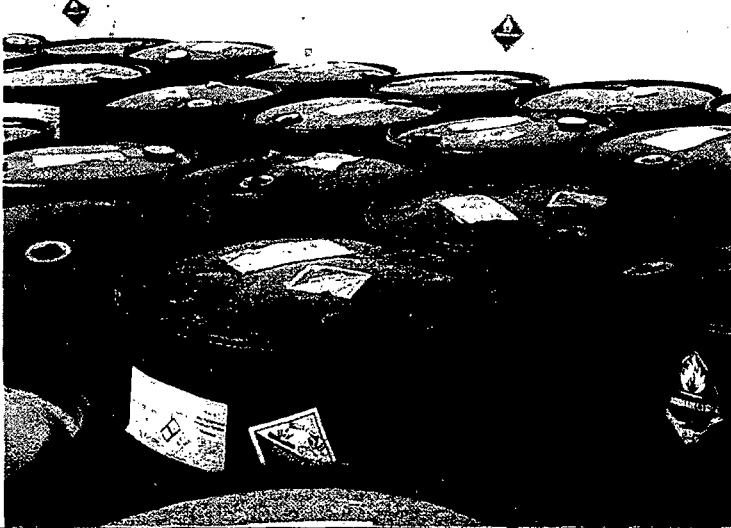
Location:		Diaz Intermediates Corp., 301 Wyanoke Rd., West Memphis, AR 72301						
Photographer:		Les Branscum, ADEQ			Witness:		Penny Wilson, ADEQ	
Photo #	40	Of	67		Date:	28 AUG 07	Time:	1408
Description:		Bulging lid on corrosive labeled drum in row 11. Product label indicates the drum contains 'HCL/HBR mix HG>1.1', DATED 1-21-07.

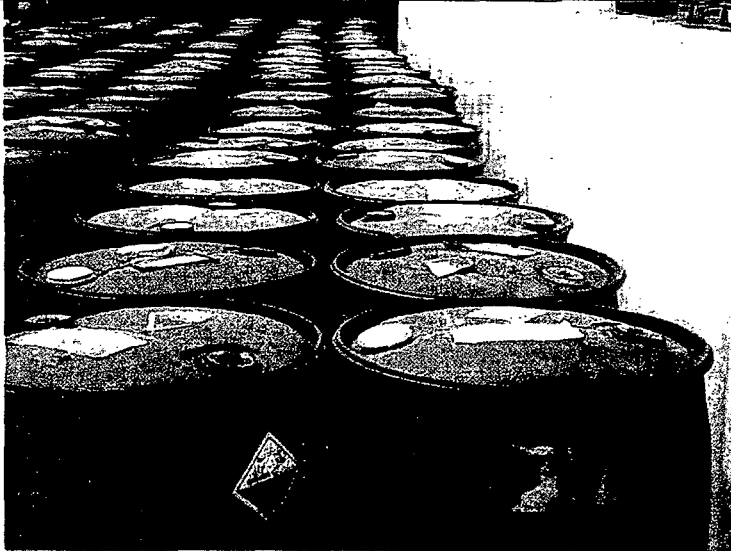
Photographer:		Les Branscum, ADEQ			Witness:		Penny Wilson, ADEQ	
Photo #	41	Of	67		Date:	28 AUG 07	Time:	1409
Description:		Rows 13&14 on drum pad, facing west.

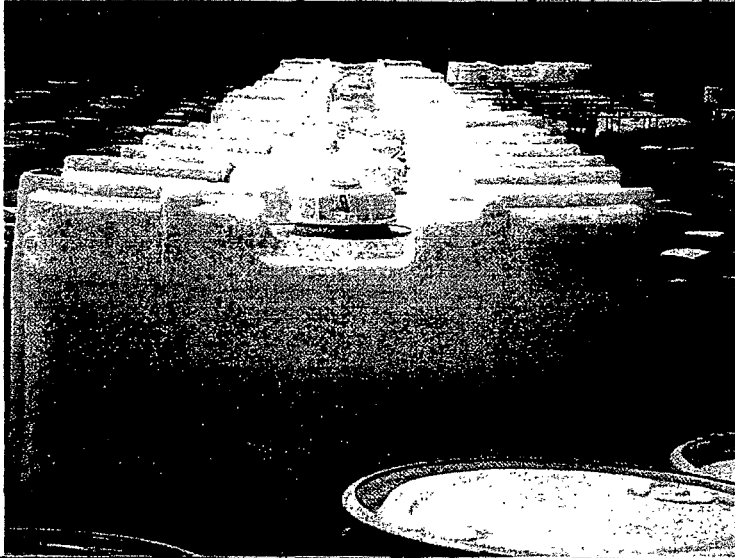
Location:	Diaz Intermediates Corp., 301 Wyanoke Rd., West Memphis, AR 72301						
Photographer:	Les Branscum, ADEQ				Witness:	Penny Wilson, ADEQ	
Photo #	42	Of	67		Date:	28 AUG 07	Time: 1410
Description:	Row 15 on drum pad, facing west. Totes are labeled 'Methanol'.

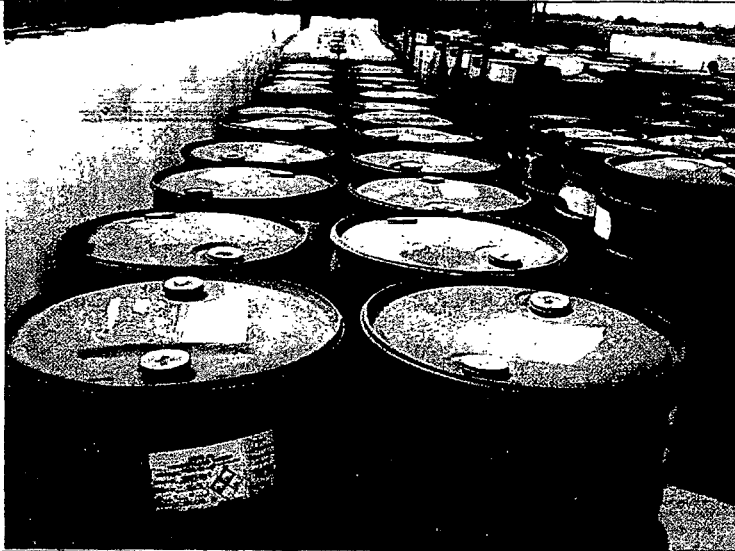
Location:	Diaz Intermediates Corp., 301 Wyanoke Rd., West Memphis, AR 72301						
Photographer:	Les Branscum, ADEQ				Witness:	Penny Wilson, ADEQ	
Photo #	44	Of	67		Date:	28 AUG 07	Time: 1413
Description:	Row 17 facing west, majority of row is totes two drums wide.

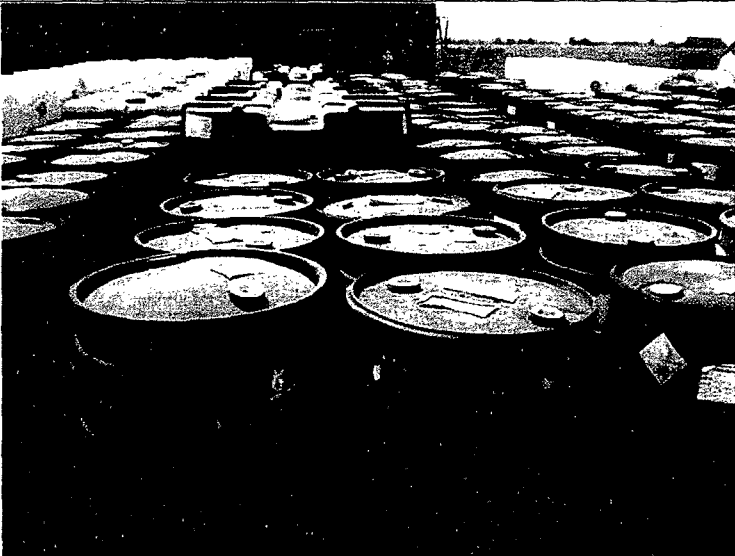
Photographer:	Les Branscum, ADEQ				Witness:	Penny Wilson, ADEQ	
Photo #	45	Of	67		Date:	28 AUG 07	Time: 1416
Description:	Row 18 facing west, front drum is labeled 'Bromobenzene PDBB-Extraction'.

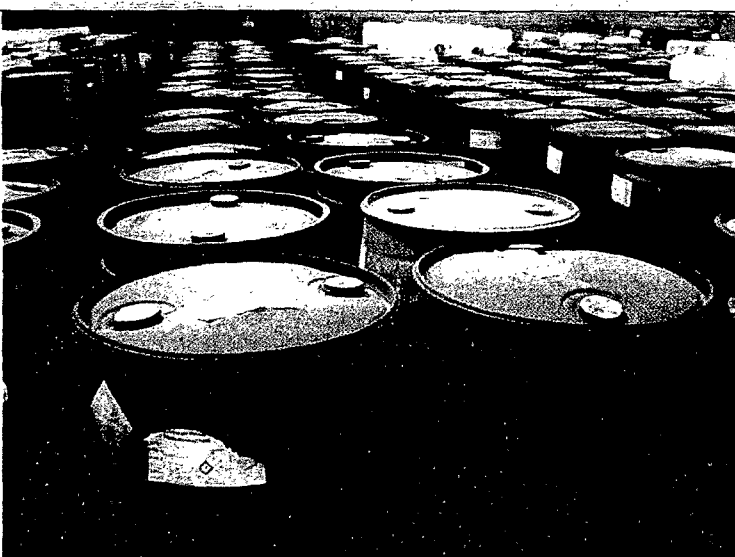
Location:		Diaz Intermediates Corp., 301 Wyanoke Rd., West Memphis, AR 72301						
Photographer:		Les Branscum, ADEQ			Witness:		Penny Wilson, ADEQ	
Photo #	46	Of	67		Date:	28 AUG 07	Time:	
Description:		Row 19 facing west. Blue drum is labeled 'Bromobenzene Pot Bottoms'.

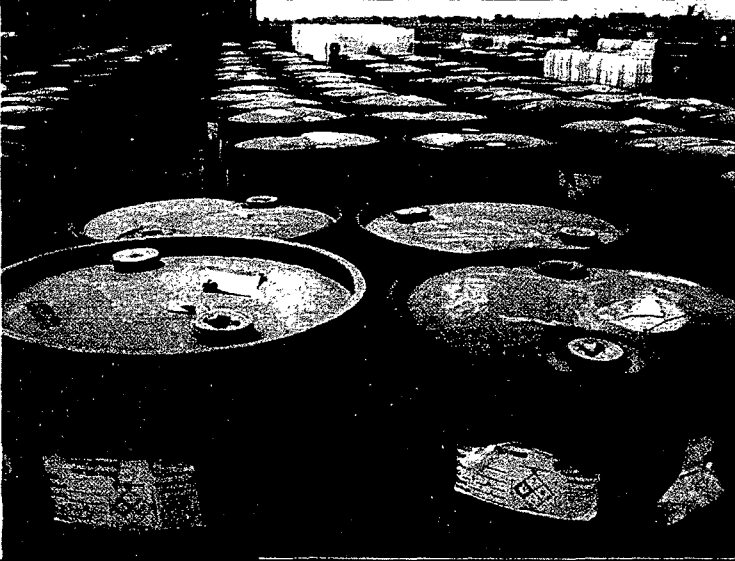
Photographer:		Les Branscum, ADEQ			Witness:		Penny Wilson, ADEQ	
Photo #	47	Of	67		Date:	28 AUG 07	Time:	
Description:		Row 20 facing west on drum pad. Drums in front are labeled 'm-Bromofluorobenzene Recycle'.

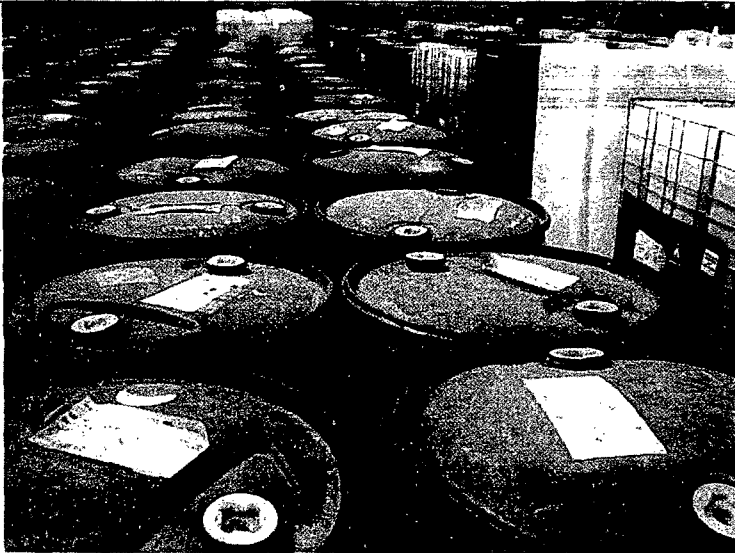
Location:		Diaz Intermediates Corp., 301 Wyanoke Rd., West Memphis, AR 72301					
Photographer:		Les Branscum, ADEQ			Witness:		Penny Wilson, ADEQ
Photo #	48	Of	67		Date:	28 AUG 07	Time: 1423
Description:		Last rows on drum pad progressing from south to north. Photo is facing NW.

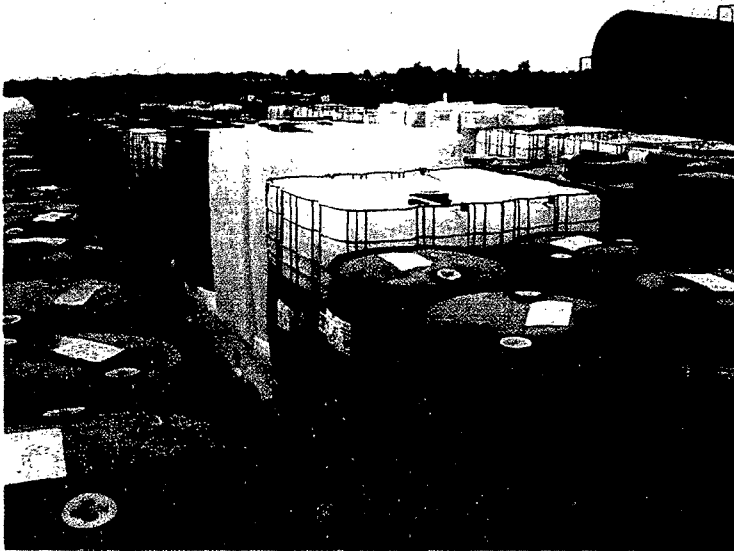
Photographer:		Les Branscum, ADEQ			Witness:		Penny Wilson, ADEQ
Photo #	49	Of	67		Date:	28 AUG 07	Time: 1425
Description:		Drum in upper left corner of photo 48 that appeared black with a blue lid. Drum is discolored by contents. Label indicates contents are 'Fluorobenzene (Recovered) Acidic' and dated 6-30-07.

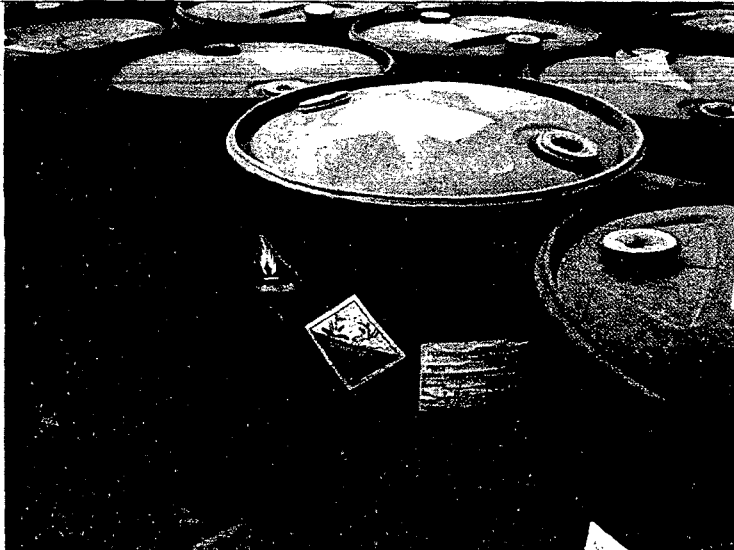
Location:	Diaz Intermediates Corp., 301 Wyanoke Rd., West Memphis, AR 72301						
Photographer:	Les Branscum, ADEQ				Witness:	Penny Wilson, ADEQ	
Photo #	50	Of	67		Date:	28 AUG 07	Time: 1426
Description:	Drums at east end of drum pad, facing north. Drum to right is labeled 'MBFB Nondistilled Water'

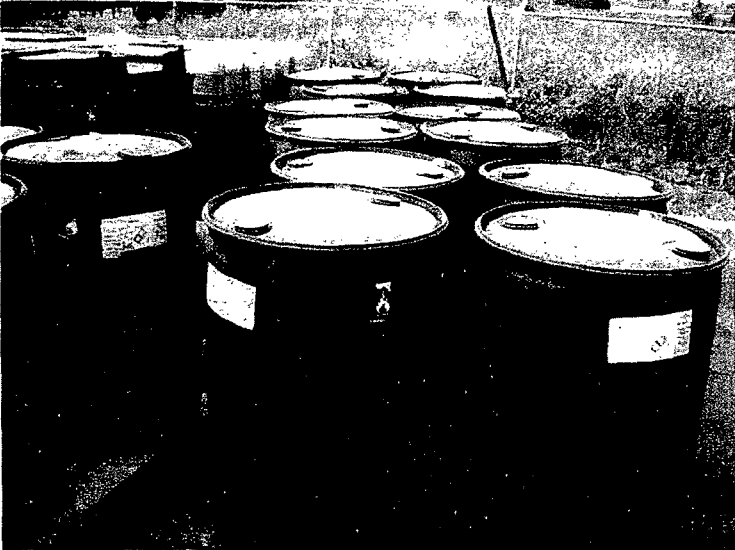
Photographer:	Les Branscum, ADEQ				Witness:	Penny Wilson, ADEQ	
Photo #	51	Of	67		Date:	28 AUG 07	Time: 1431
Description:	Drums on East end of drum pad, (drums in photo 50 are in upper left corner) majority are non-hazardous.

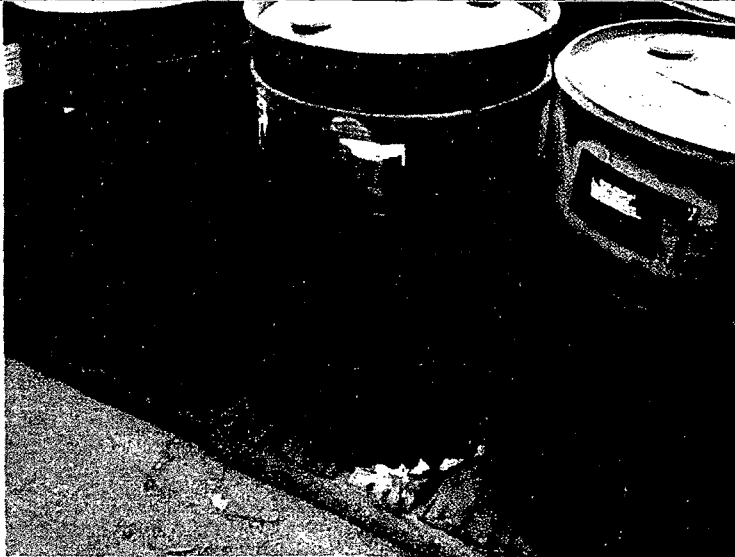
Even though there are numerous containers of different type materials on-site, we only observed one (1) 55-gallon container that had leaked. (Refer to Attachment #4, Photographs #52 and #53.) This container was labeled Bromobenzene and the area where the leak occurred is now covered with a crystal-like substance.

NOTE: One (1) 55-gallon poly drum of Bromobenzene was found to be leaking at the bottom of the drum with a crystal-like material at the leak.

Location:	Diaz Intermediates Corp., 301 Wyanoke Rd., West Memphis, AR 72301						
Photographer:	Les Branscum, ADEQ				Witness:	Penny Wilson, ADEQ	
Photo #	52	Of	67		Date:	28 AUG 07	Time: 1434
Description:	Leaking drum on right side of drums in photo 51.

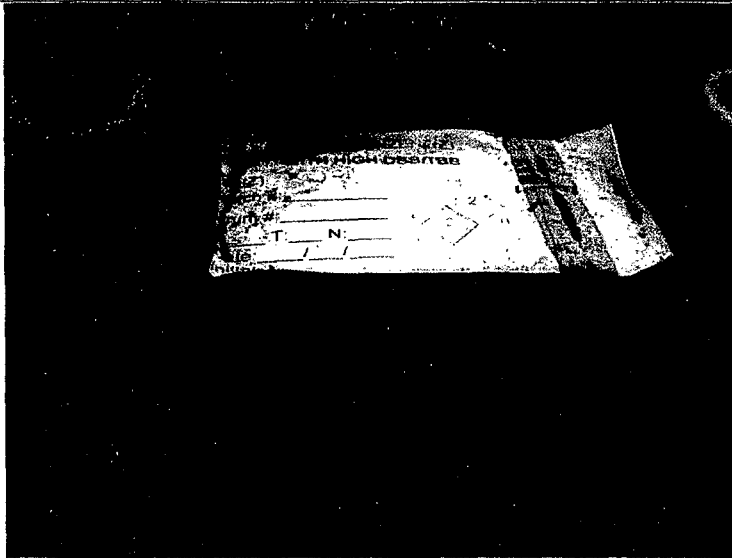
Location:	Diaz Intermediates Corp., 301 Wyanoke Rd., West Memphis, AR 72301						
Photographer:	Les Branscum, ADEQ				Witness:	Penny Wilson, ADEQ	
Photo #	54	Of	67		Date:	28 AUG 07	Time: 1437
Description:	Close up of label on damaged drum. Label indicates contents are 'Bromobenzene (Z) with high DBB/TBB'.

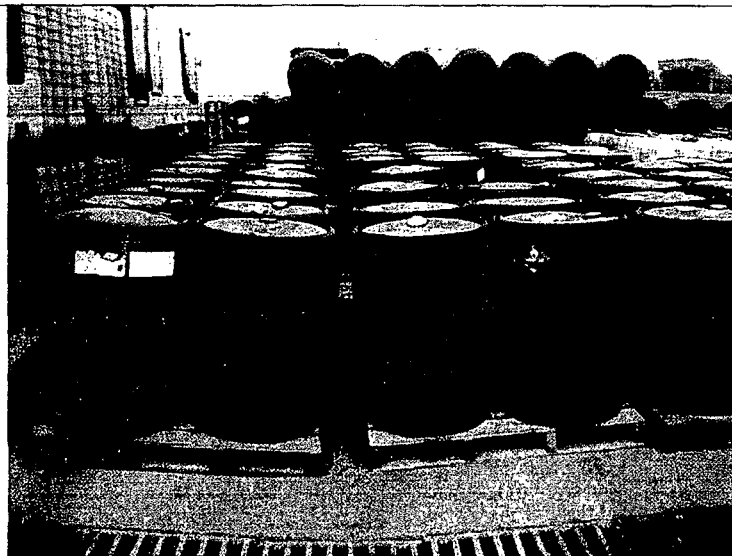
Location:	Diaz Intermediates Corp., 301 Wyanoke Rd., West Memphis, AR 72301						
Photographer:	Les Branscum, ADEQ				Witness:	Penny Wilson, ADEQ	
Photo #	56	Of	67		Date:	28 AUG 07	Time: 1439
Description:	Continuation of drums in photo 55, facing east. Process Building is to the right in background.

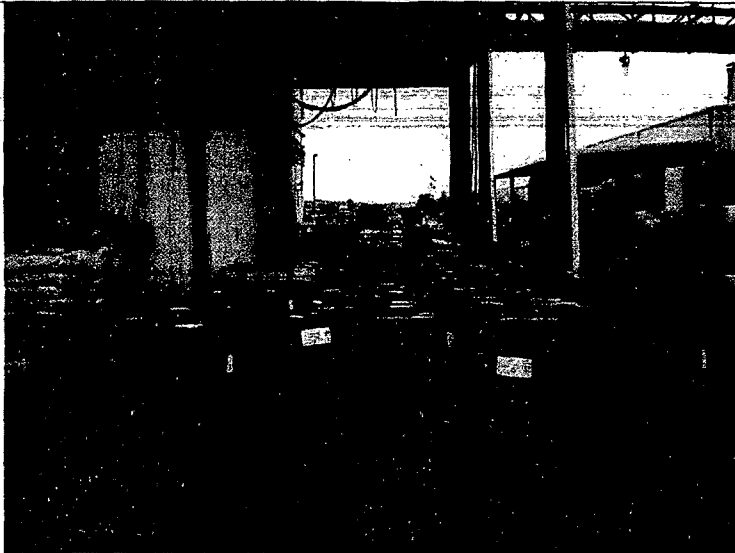
Location:		Diaz Intermediates Corp., 301 Wyanoke Rd., West Memphis, AR 72301						
Photographer:		Les Branscum, ADEQ			Witness:		Penny Wilson, ADEQ	
Photo #	58	Of	67		Date:	28 AUG 07	Time:	1448
Description:		Drum labeled 'Hydrobromic Acid' at south end of Bulk Truck Pad.

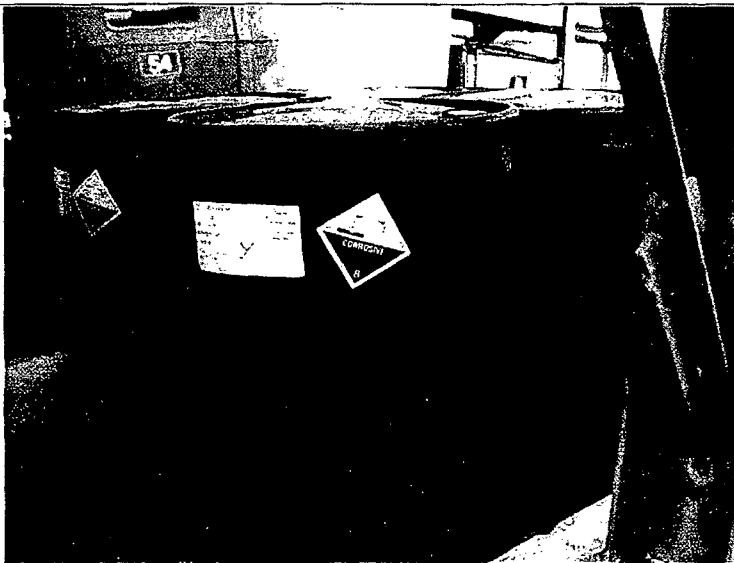
Photographer:		Les Branscum, ADEQ			Witness:		Penny Wilson, ADEQ	
Photo #	59	Of	67		Date:	28 AUG 07	Time:	1448
Description:		Close up of drum in photo 58 showing date of 7-19-05.

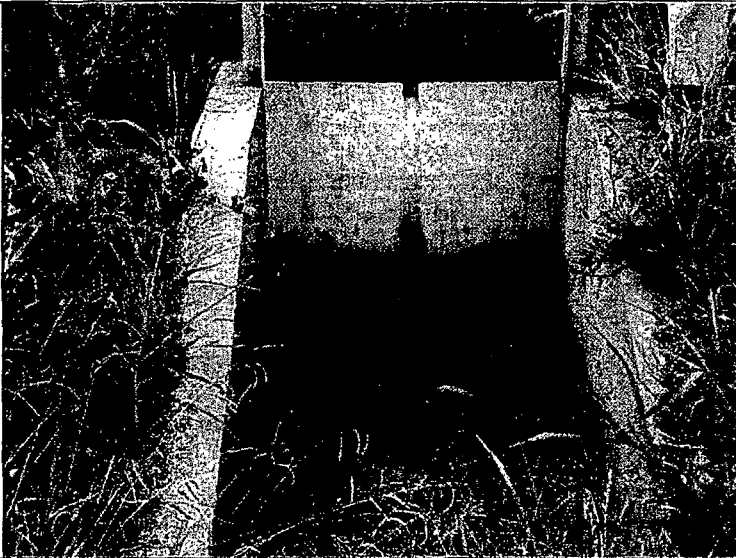
Photographer:		Les Branscum, ADEQ				Witness:		Penny Wilson, ADEQ	
Photo #	67	Of	67		Date:	28 AUG 07	Time:	1550	
Description:		Storm drain fully closed with dirt pushed against it to help seal.
